# Fire Tests of Load-Bearing, Light-Steel-Framed Wall Systems Insulated with Polyurethane Foam

**Abstract:** This paper presents the details of three fire tests conducted on light-steel-framed (LSF), load-bearing wall systems, which consist of polyurethane insulation injected into the cavities of the steel frame between two or three layers of gypsum fibreboard. To investigate the thermal and structural performance limits under standard fire conditions, observations were made during the tests, and temperatures and vertical displacements were recorded. Although combustible insulation was used, the results obtained are promising for the application of studied LSF wall systems in buildings, where fire resistance of more than 60 min is required.

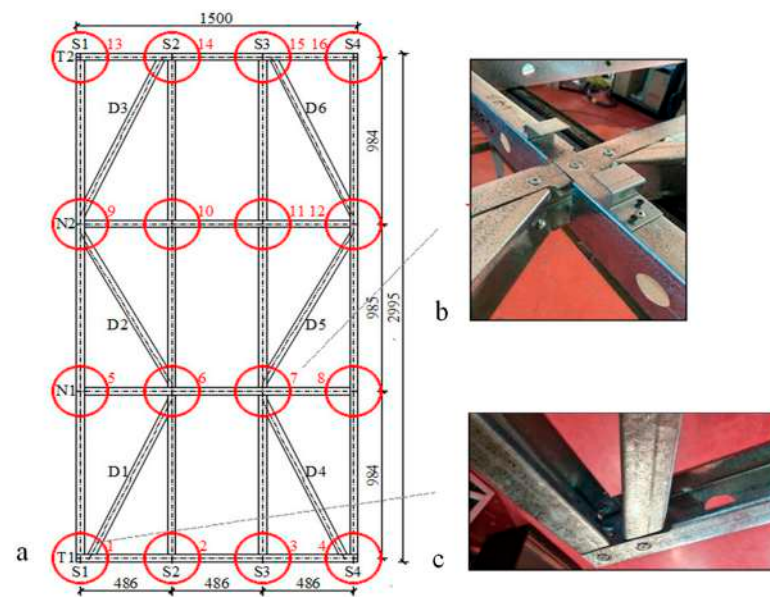
The experimental study was conducted on three load-bearing LSF wall panel specimens consisting of a steel frame, PUR foam as cavity thermal insulation and GFBs as sheathing wallboards. The dimensions of the specimens were 1.5 m wide and 3.0 m high. The members of the steel frame steel (studs, tracks and noggings), consisted of 0.95 mm thick C-sections with dimensions of 89 × 42 × 10 mm. The C-sections were made of S550 GD steel sheets. A total of four studs (labelled S1, S2, S3 and S4) with a length of 2995 mm, two tracks (labelled T1 and T2), and two noggings (labelled N1 and N2) with a length of 1500 mm were used to construct the steel frame, as shown in Figure 1b.

The studs were located at 486 mm from the centre axis off-centre, while the noggings were located 984 mm off-centre from the top and bottom tracks. A total of 16 nodes (numbered 1–16 in Figure 1a) were formed. The members of the steel frame were fixed with self-tapping flat-head screws with dimensions 6 × 19 mm and a diameter of 3.5 mm. To ensure the physical distance between the inner sheathing wallboards and the steel frame, 6 steel Z shaped spacers (Figure 1b) were placed on both sides of the specimen at certain positions along the length of studs S2 and S3 and noggings N1 and N2. The spacers were made of the same type of steel as all other steel members.

**Figure 1.** Layout of the LSF wall frame and characteristic connection details: (a) steel frame; (b) Z-shaped spacers near the node, (c) cut-out of the steel frame. Red circles numbered 1–16 indicate the 16 nodes formed in the steel frame.

Post-test inspection of the tested specimens revealed that the cavity insulation was completely burned, leaving only layers of charcoal (Figure 9), while the steel members around nodes in central studs (N6 and N7 according to Figure 1) were deformed in all three specimens (Figure 9c,d). It was also noted that the GBFs were still attached to the steel structure at the top and near the bottom of the specimen. This led to the conclusion that the failure of the exposed GBF was localized and probably occurred about 1 m from the bottom of the specimen. At this location, the fire from the furnace entered the cavity, resulting in decomposition of insulation. This is confirmed by the results of the infrared thermography monitoring and thermograms taken on specimen P1 at the 67th and 76th minutes of testing, Figure 11.

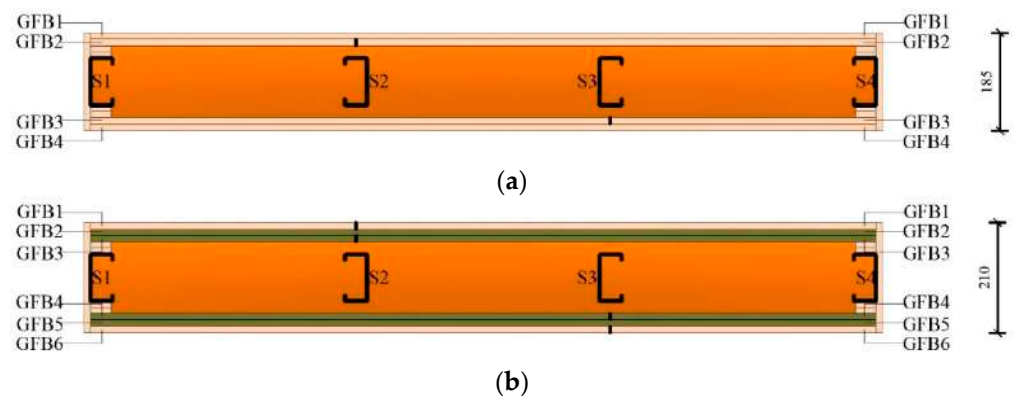
The steel frame was lined on both sides with two or three layers of GFBs, respectively. Two types of 12.5 mm GFBs were used from the same manufacturer (James Hardie Europe GmbH, Düsseldorf, Germany), GFB with density  $1150 \pm 50 \text{ kg/m}^3$  and reaction to fire A2, s1-d0 [31], A2 GFB onwards, and GFB with improved fire properties (density  $1250 \pm 50$  and reaction to fire A1 [32]), A1 GFB onwards. Two of the specimens (designated as Specimen P1 and Specimen P2, Figure 2a) were of the same composition, double-lined on both sides with A1 GFB, while one specimen (designated as Specimen 3, Figure 2b) was triple-lined with an outer layer of A1 GFB and two inner layers of A2 GFB. A2 GFBs are shown in green, while the A1 GFBs are shown in light orange.

**Figure 2.** Wall configurations used in the fire tests: (a) Cross section of the double lined specimens (P1 and P2); (b) cross section of triple lined specimen (P3).

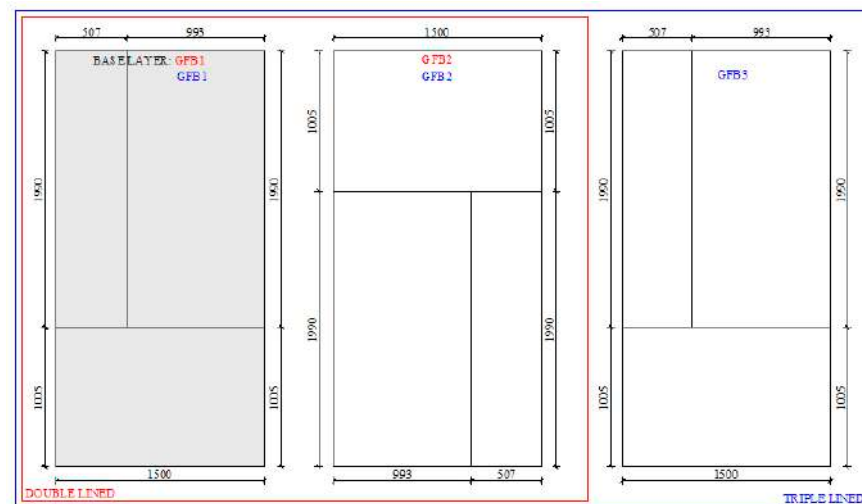
Three differently cut pieces with approximate dimensions of  $500 \times 1990 \text{ mm}$ ,  $1000 \times 1990 \text{ mm}$  and  $1005 \times 1500 \text{ mm}$  were used for each layer of the sheathing, as shown in Figure 3.

**Figure 3.** GFB wallboard lining configuration. The red box indicates the wallboard configuration for double-lined, while blue box for triple-lined LSF walls.

The layout of the ambient side wallboard is a mirror image of the fire-side wallboards. The joints of the base layer boards (GFB2, GFB3 for double-lined specimens and GFB3 and GFB4 for triple-lined specimens) were secured with mesh and paper tape and filled with the fireproof joint filler. In addition, joints, screw holes and the wallboard strips on S1, S4, N1 and N2 were coated with a thin layer of fireproof joint filler. After lining the steel structure, the cavity of the panel was filled with a two-component PUR foam with the following properties: density 45 kg/m<sup>3</sup> with a tolerance of  $\pm 5\%$ , thermal conductivity in the range of 0.020–0.023 W/mK and reaction to fire class E according to the manufacturer's specifications. Injection of PUR into the test specimens was performed with a low-pressure injector at a pressure of 5–10 bar and was completed within an hour for each specimen.

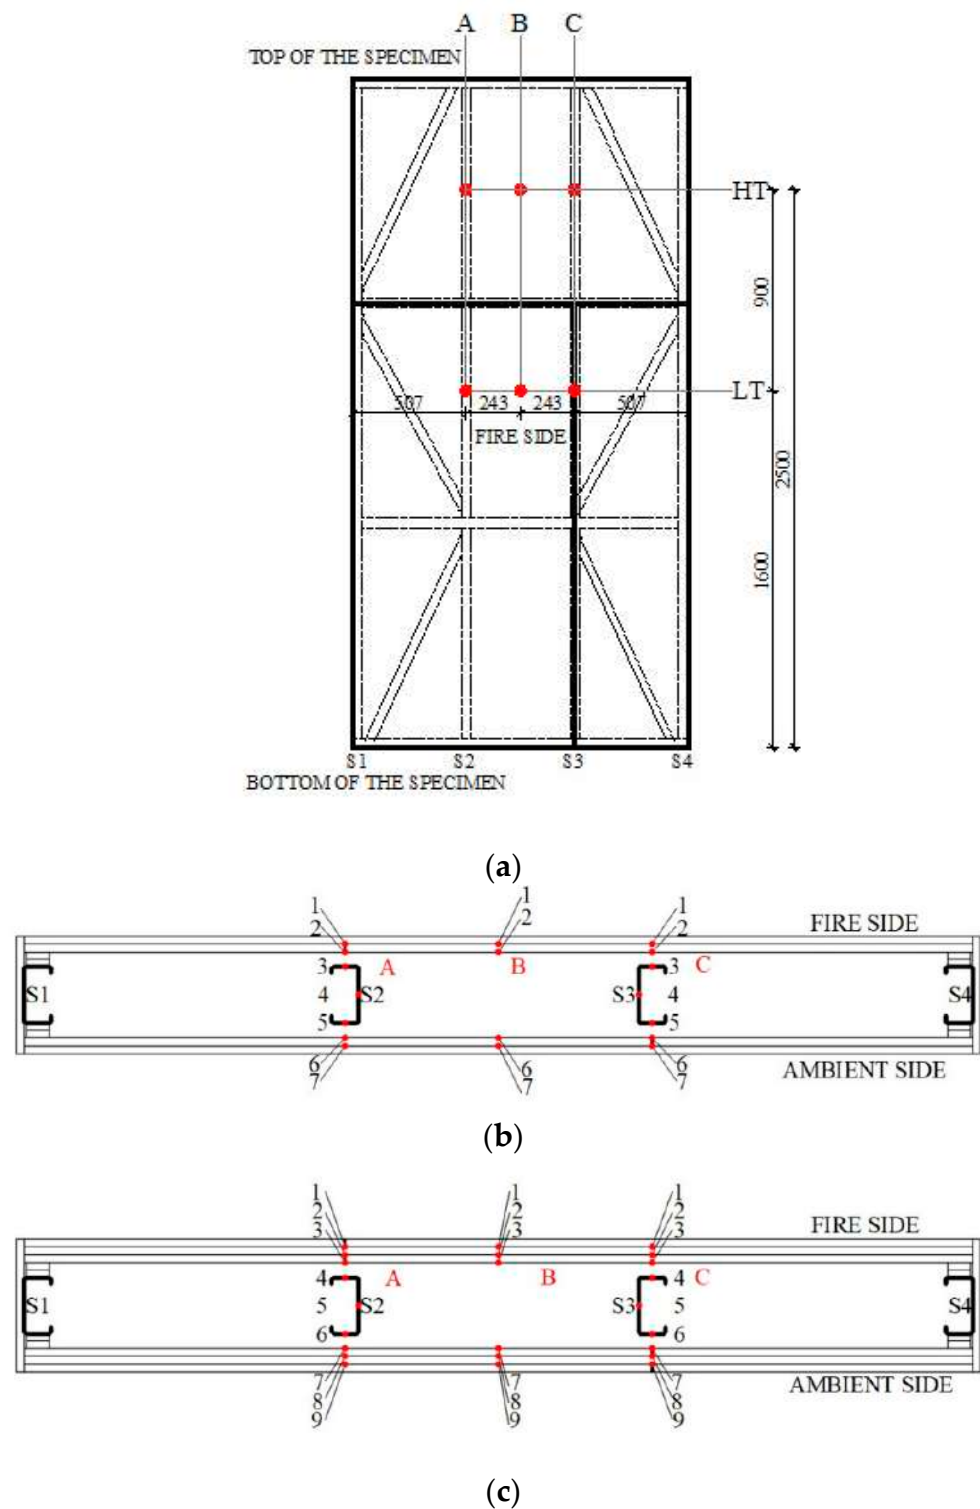
K-type thermocouples (NiCr-Ni) were installed on the ambient side of the wall panels in accordance with EN 1365-1 [33]. Additional thermocouples of the same type were installed, before filling the cavity with PUR foam, for monitoring the temperature development throughout the test panel—horizontally at three positions (A, B and C) at two heights, 1600–1650 mm (low, LT) and 2500–2550 mm (high, HT) from the bottom track, as shown in Figure 4a. Through the cross sections of the tested panels, the thermocouples were placed as follows (Figure 4b,c):

1. Between wallboard layers on both sides (ambient and fire side)—labelled 1, 2, 6 and 7 for double-lined specimens and 1, 2, 3, 7, 8 and 9 for triple-lined specimens.
2. On the hot and cold flanges and on the web of the lipped channel, C-shaped steel studs—marked 3, 4 and 5 for double-lined specimens and 4, 5 and 6 for triple-lined specimens.

A total of 42 thermocouples were installed in double-lined specimens and 54 in the triple-lined specimen. The thermocouples were welded to copper disks with a diameter of 12.0 mm and a thickness of 0.2 mm. The furnace temperature was measured using six K-type plate thermocouples symmetrically placed inside the furnace chamber at about 100 mm from the exposed surface of the specimen in accordance with EN 1363-1 [34].

**Figure 4.** Thermocouple positions through the cross-sections of the specimens: (a) Front side of the test specimens; (b) cross-sections of specimens P1 and P2; (c) cross-section of specimen P3.

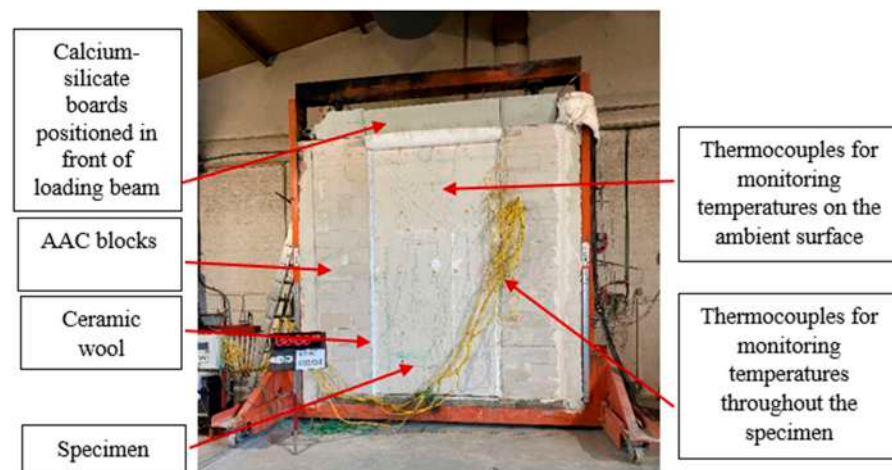
The opening of the furnace was 3.0 m wide and 3.0 m high and the additional width of the furnace opening was filled with non-combustible autoclaved aerated concrete (AAC) blocks and ceramic wool (with a density of 130 kg/m<sup>3</sup> and a thickness of 25.4 mm) on both sides of the test specimen. Figure 5 shows the specimen test set-up.

The specimen was loaded with a specially designed beam providing a total load of 22.5 kN, i.e., a uniform load of 15 kN/m on the top of the specimen. The load was applied to the beam 20 min before the start of the test using hydraulic jacks and maintained throughout the test. The bottom of the specimen was secured with bolts that connected the specimen to a reinforced concrete slab. The specimen was unloaded when a steep increase in displacement was observed, and the structure tended to collapse. As combustible thermal insulation was used in specimens, the complete collapse of the specimen could damage the test equipment and endanger the safety of the laboratory personnel. The burners of the furnace were turned off with the delay after unloading when the rapid increase in temperatures of steel members was observed. The vertical deformations of the specimens were measured using displacement transducers placed at the top of the specimen, between the load beam and the fixed frame, recording the distances between the load beam and the fixed frame. The changes in this distance correspond to the measured vertical displacements of the specimen. In addition, thermographic measurements were taken with an imaging camera during the fire test of specimen P1 to record the heat evolution on the whole unexposed side, which allowed a better understanding of the failure mode. The target fire curve was set in accordance with EN 1363-1 [34] using 6 radiant burners. The air temperature in the test area was maintained at 20 ( $\pm 5$ ) °C for 24 h prior to the fire test. The temperature readings of the thermocouples and the vertical displacements of the specimens were taken at 1 min intervals.

**Figure 5.** Specimen set-up in the testing furnace.

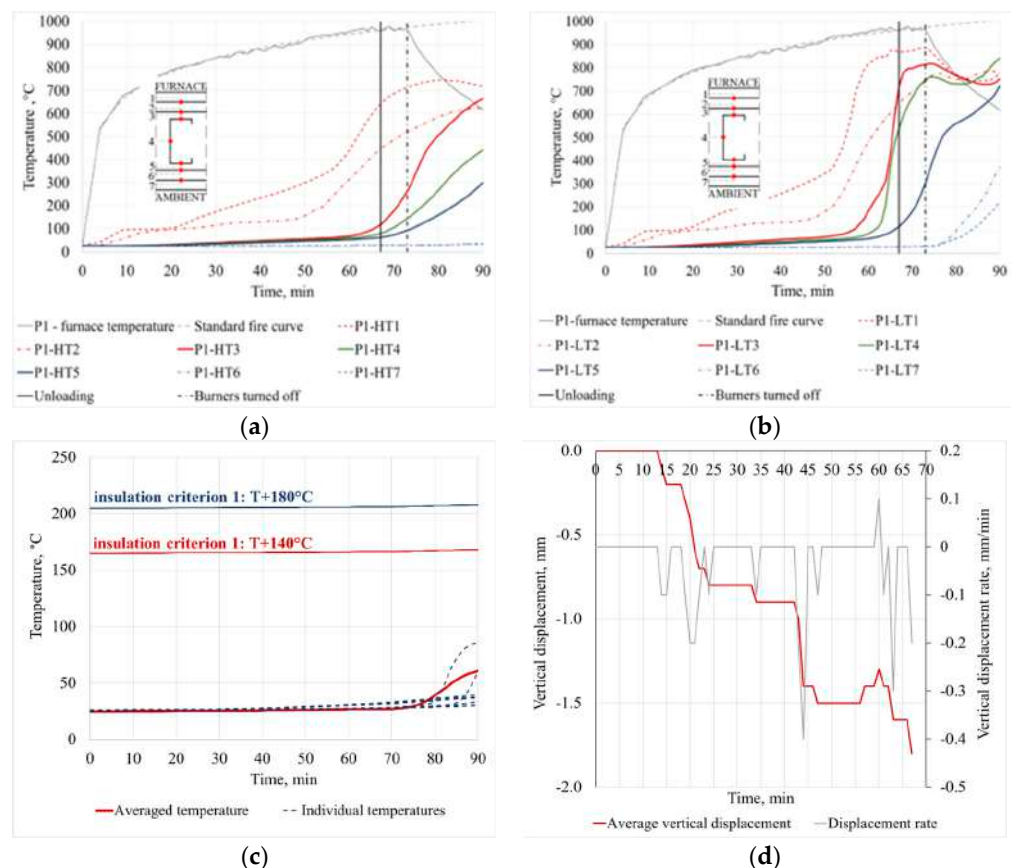
Specimen P1 consisted of double A1 gypsum fibre-boards on both sides. It was unloaded at the 67th minute because, as will be shown later, there was a threat of possible structural collapse. No smoke, flames, discolouration or cracks were observed on the ambient side of the specimen by the end of the test, indicating that the integrity failure criterion in accordance with EN 13501-2 [6] for FRR was not achieved. The temperature–time profile obtained in the furnace can be seen in Figure 6a,b and agrees well with the standard fire curve within the limits prescribed by EN 1363-1 [34]. Temperatures through the cross-section are presented as average values measured on thermocouples placed at the same height: upper (2500–2550 mm, HT) in Figure 6a and lower (1600–1650 mm, LT) in Figure 6b. As shown in Figure 6a, the temperature between the two wallboards (thermocouple P1-HT1) remained below 100 °C (temperature

plateau) for a period of about 20 min after the start of the test when the temperature in the furnace had already reached about 800 °C. This delay in the temperature rise was due to the dehydration process of free and bound water in the GFBs [35,36]. After 20 min of fire exposure, the temperature recorded at thermocouple P1-HT1 increased significantly and reached maximum value of 746 °C in the 80th minute (the burners had already been turned off). At the position between the second wallboard and the PUR foam (thermocouple P1-HT2), the delay in the temperature rise extended to around 48 min of fire exposure, when the temperature started to continuously increase up to the end of the test. Temperatures at the steel sections (thermocouples P1-HT3, P1-HT4 and P1-HT5) began to rise steeply about 60 min after the start of the test, reaching 117 °C, 80 °C and 63 °C at the time of specimen unloading, and 665 °C, 442 °C and 302 °C in the 90th minute at the hot flange, web and cold flange, respectively. Compared to the temperature profiles obtained at the upper position, the average temperatures recorded at the lower positions (LTs—see Figure 6b) are similar up to the 50th minute of fire exposure when the steeper temperature rise at all thermocouple positions was observed. When the specimen was unloaded (67th min), temperatures of 722 °C, 539 °C and 115 °C were recorded at the hot flange, web and cold flange, respectively, while the maximum temperatures were recorded after the burners were turned off and were 818 °C, 842 °C and 724 °C respectively. These temperatures indicate that the recrystallization point of the steel was reached, which would result in significant deformation and loss of (local) structural stability of the steel members.

**Figure 6.** Fire test results for specimen P1: (a) average temperatures at high position (HTs); (b) average temperatures at low position (LTs); (c) temperature profiles at the unexposed side of the specimen; (d) average vertical displacement and displacement rate.

Figure 6c presents the individual and the average temperatures on the unexposed side of the tested wall indicating that the insulation failure criterion (average temperature rise of 140 °C and 180 °C on individual thermocouples, respectively) according to EN 13501-2 [6]

was not reached. The highest average temperature was 61 °C and the highest individual temperature was 86 °C observed after the burners were turned off. As Figure 6d shows, the specimen deformed continuously from the 15th minute until the unloading. From the 15th to the 25th minute, there was a sudden increase in deformations, followed by a stable phase. During this period, the temperatures at the exposed specimen side (P1-HT1 and P1-LT1) were increasing from a stable stage (100 °C), as shown in Figure 6a,b. A sudden increase in the vertical displacement can also be seen at the 45th minute (vertical displacement rate of 0.4 mm/min), which can be attributed to the recorded board falling off, followed by a further increase in the 60th minute. This increase could be attributed to the rising temperatures at the steel frame members (P1-LT3, Figure 6b).

Thermographic measurements showed that the predominant heat transfer occurred in the lower third of the specimen, which is consistent with the temperature–time curves shown in Figure 6a,b. As can be seen from the figures, a significant temperature increase (maximum temperature above 100 °C was achieved) was observed at the nodes positioned at the lower part of the specimens (around nodes N6 and N7). This higher temperature is directly correlated with the position of joints (as shown in Figure 3) implying that the joints failed first and the PUR insulation degraded around this location first. This resulted with heat being transmitted through the boards and consequently to the non-exposed surface of the specimen. Additionally, higher temperatures than the surroundings are observed in the areas where spacers and screws are positioned.

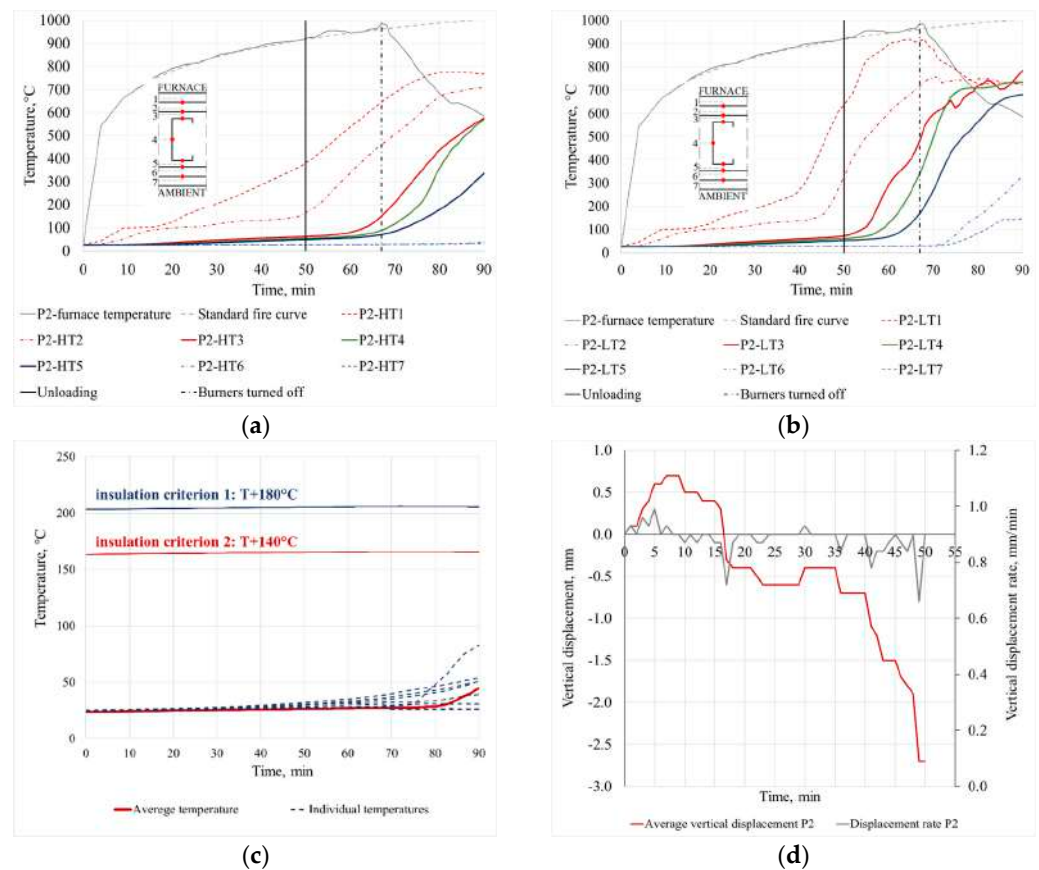
Specimen P2 was of the same composition as specimen P1 and was tested to check uniformity of the test results. However, the specimen had to be unloaded earlier, at the 50th minute of the fire exposure while the furnace burners were shut down at the 67th minute. As with specimen P1, no smoke, water vapour or cracking was observed on the ambient side during the entire test period, indicating that the integrity failure criterion was not reached. The temperature–time profile obtained in the furnace (Figure 7a,b) agrees well with the standard fire curve within the limits prescribed. Monitored average temperatures for the upper positions are shown in Figure 7a up to 90 min. As shown in the figure, the temperature between the two wallboards (thermocouple P2-HT1) remained below 100 °C (temperature plateau), for a period of about 20 min of fire exposure and then began to rise until the end of the test. The delay in the temperature rise between the second wallboard and the PUR foam (thermocouple P2-HT2) extended to 46 min after the start of the test, when the temperature rise followed that of thermocouple between the two wallboards (P2-HT1). At the time of unloading, the temperatures at the hot flange (P2-HT3), web (P2-HT4) and cold flange (P2-HT5) were 64 °C, 55 °C and 50 °C, respectively, and reached maximum values of 577 °C, 573 °C and 336 °C, respectively, when the burners were turned off during the 90 min temperature-monitoring period. Compared to the temperature profiles shown for the upper position (Figure 7a), the average thermocouple temperatures recorded at the lower position (Figure 7b) are similar up to the 40th minute of fire exposure. However, it can be seen that after the dehydration period, the temperatures between the two wallboards (P2-LT1) increase rapidly. The same trend in temperature rise was observed at the position between base wallboard and PUR foam (P2-LT2) with later start of temperature rise. At the 50th min of exposure time (unloading), temperatures of 76 °C, 62 °C and 53 °C were recorded at the hot flange (P2-LT3), web (P2-LT4) and cold flange (P2-LT5), respectively, and reached maximum values of 783 °C, 734 °C and 681 °C, respectively, after turning off the radiant burners.

As for specimen P1, the individual and average temperature recorded on the unexposed wallboards shown in Figure 7c indicate that the insulation failure criteria were not reached. Figure 7d presents the vertical deformations that occurred during the 50 min fire test. Until the 15th minute, the specimen expanded due to the increasing heat, then there was a sudden increase in the opposite direction, i.e., the direction of the applied load. From the 20th minute, the temperatures at the exposed specimen side (P1-HT1 and P1-LT1—see Figure 7a,b) started to increase from stable stage (100 °C). Until the 35th minute, the specimen remained stable with no significant deformation observed. From this point on, the specimen deformed continuously with high displacement rate (from 0.4 mm/min to almost 0.8 mm/min), indicating a possible collapse of the structure. Consequently, the specimen was unloaded at the 50th minute.

**Figure 7.** Fire test results for specimen P2: (a) average temperatures at high positions (HTs); (b) average temperatures at low positions (LTs); (c) temperatures recorded at the unexposed side of the specimen; (d) average vertical displacement and displacement rate.

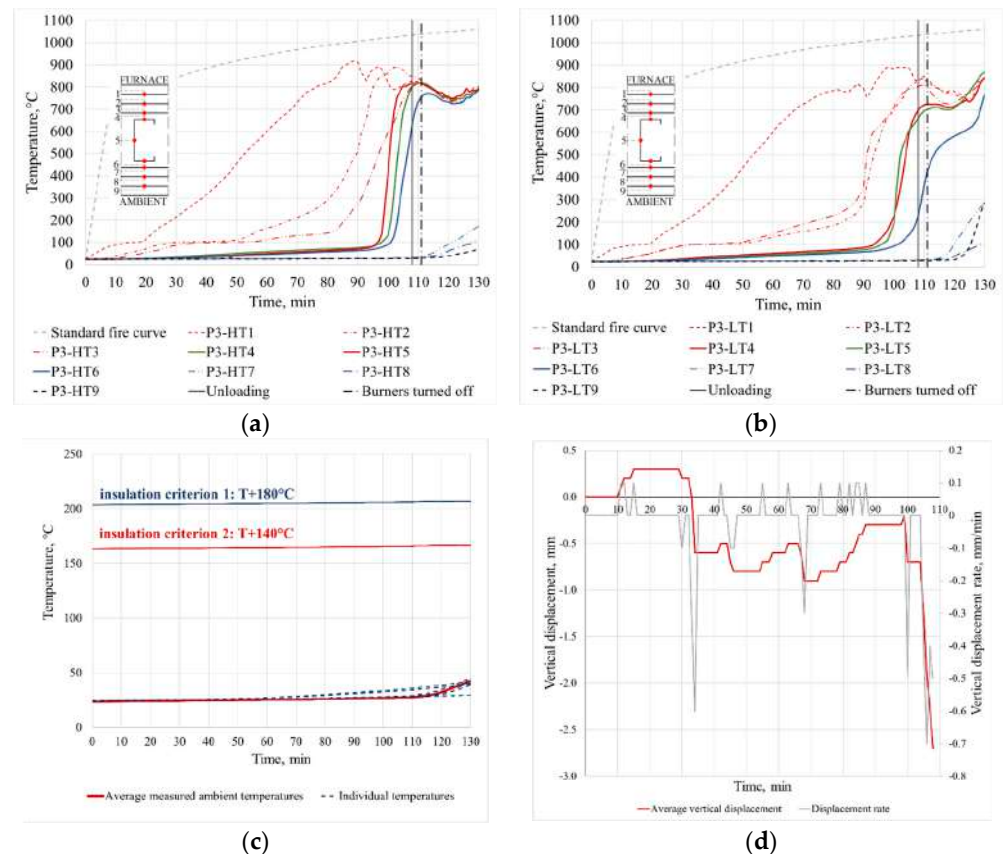
Specimen 3 was tested to observe the benefit of an additional layer of wallboard on the FRR. The specimen consisted of triple gypsum fibreboards on both sides (two A2 GFBs and one A1 GFB). Specimen 3 was unloaded at the 108th minute and the burners were turned off in the 111th minute. No smoke, water vapour, flames or cracks were observed on the ambient side of the specimen throughout the test, indicating that the integrity failure criterion was not reached. Monitored average temperatures for the upper positions up to 130 min after the start of the test are shown in Figure 8a.

From the figure, it can be seen that the temperature between the two wallboards (thermocouple P3-HT1) remained below 100 °C for a period of about 20 min after the start of the test (temperature plateau) and then began to rise steeply. The temperature at the boundary between the base layer (GFB3) and the insulation (P3-HT3) remained below 100 °C until 60 min of fire exposure. After the initial delay, the temperature increased very slowly until the 90th minute and then increased rapidly to 814 °C at the 110th minute. Temperatures at the steel sections (thermocouples P3-HT4, P3-HT5 and P3-HT6) began to rise rapidly about 95 min after the test had started reaching maximum values of 819 °C at the hot flange and web of steel profile, and 785 °C at the cold flange. The average temperatures recorded on the lower positions of P3 (see Figure 8b) are similar to those recorded at upper positions up to the 50th minute of fire exposure, with some differences thereafter. Very similar temperature profiles were obtained at the position between the exposed and middle (i.e., PL3-LT2) and between the middle and base layers (i.e., PL3-LT3) of the gypsum fibreboards. The temperatures recorded on the steel studs (P3-LT4, P3-LT5 and P3-LT6) started to increase almost at the same time (95th minute) as those recorded at high position (P3-HT4, P3-HT5 and P3-HT6) and maximum values of 845 °C, 867 °C and

768 °C, respectively, were reached. From the aforementioned figures, temperature–time curves for positions 1–6 follow the same pattern after the specimens were unloaded and burners were shut down. The stagnation in temperature rise was then observed, which was followed by a temperature increase in the last 10 min, although there was no heat output from the furnace. Fast temperature rises at each position throughout the cross-section of the specimen were obviously a consequence of PUR burning. At the ambient side (Figure 8c), the obtained maximum individual and average temperatures were around 45 °C, which was below the insulation criteria for FRR.

**Figure 8.** Fire test results for specimen P3: (a) average temperatures at high positions (HTs), (b) average temperatures at low positions (LTs); (c) temperatures recorded at the unexposed side of the specimen; (d) average vertical displacement and displacement rate.

As Figure 8d shows, the specimen vertically expanded due to the increased heat from the 12th to the 33rd minute. After the initial expansion, the measured vertical displacements show a steady increase in the direction of the applied load (vertical displacement rate of 0.6 mm/min). At the 33rd minute, the temperatures between GFB1 and GFB2 were 220–240 °C. After the initial propagation, the vertical displacements remained stable with only small fluctuations until the 99th minute. At the 99th minute, a sharp increase in the measured vertical displacements (vertical displacement rate from 0.5 mm/min to 0.7 mm/min) occurred, possibly leading to collapse of the structure.

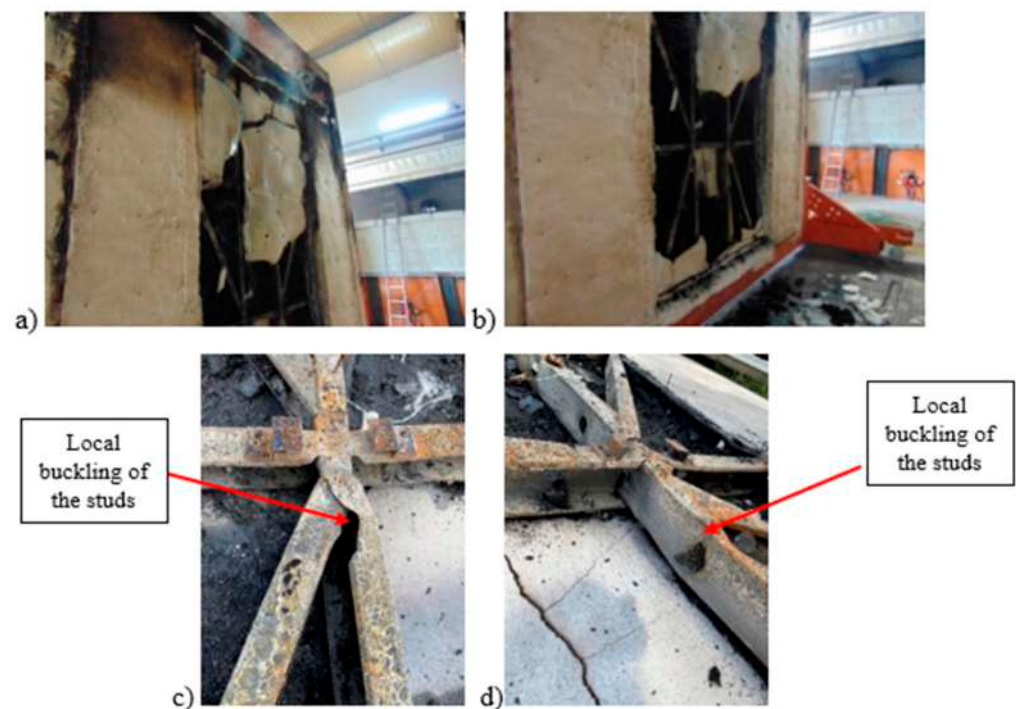
Post-test observations of all tested specimens indicate that all wallboards on the exposed side collapsed completely, and the PUR foam was almost completely charred. The steel members exhibited localised buckling around relatively rigid nodes 6 and 7. Global buckling of top diagonal members (under the load application position) was also recorded. For an example, Figure 9 presents the exposed side of test specimen P2.

**Figure 9.** Post test observations for specimen P2: (a) exposed side of upper part of test specimen; (b) exposed side of lower part of test specimen; (c) node 6; (d) node 7.

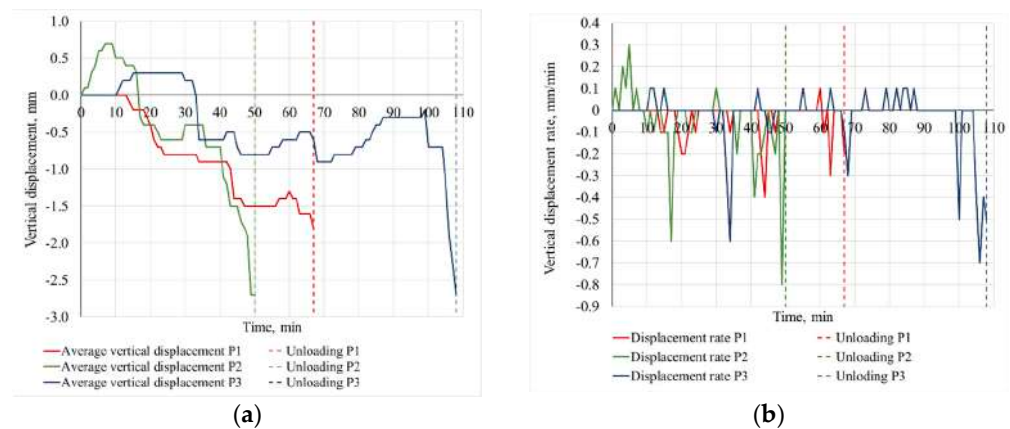
The results presented separately for each LSF specimen show similar behaviour and mode of failure during standard fire exposure. At the beginning of the test, the gypsum fibreboards protected the steel frame from a temperature rise for some time. In addition, the low thermal conductivity of the PUR foam contributed to low heat transfer through the specimen before it began to decompose. Once the free and physically bound water evaporated from the GFBs, they became susceptible to cracking, and parts of boards fell off, allowing heat to penetrate the combustible cavity insulation and steel members. For the specimens with double GFBs (specimens P1 and P2), the sudden temperature rise on the steel members started after about 50–60 min (Figures 6a,b and 7a,b), while the additional board on the specimen with triple GFBs prolonged the steep temperature rise for an additional 30 min (Figure 8a,b). When the ignition temperature for the PUR insulation was reached (between 200 °C and 300 °C), the additional heat generated by combustion contributed to the temperature rise on the steel sections and maintained the high temperatures even after the burners in the furnace were turned off. Nevertheless, the heat generated by the PUR combustion was not sufficient to raise the furnace temperature (Figures 6a,b–8a,b). Throughout the test period, all tested specimens showed no signs of integrity and insulation failure. As mentioned earlier, according to previous studies on the load-bearing cavity insulated LSF wall exposed to fire test [16–18], structural failure is usually the predominant failure mode due to the non-uniform heating of the steel members. In accordance with EN 1365-1 [33], structural failure occurs when the displacement reaches the value  $h/100$  mm (height/100) or when the displacement rate reaches a value of 3 h/1000 mm/min. This means that a displacement of 30 mm or a displacement rate of 6 mm/min must be achieved. Figure 10a shows the comparison between the average measured displacements for all tested specimens, while Figure 10b shows the comparison of the average displacement rates. During the time of unloading, the two structural failure criteria were not reached but a trend of steep increase can be observed. Since the specimens were manufactured with non-standard dimensions and unloaded earlier than the above criteria were reached, it is not possible to give an official FRR. However, the results shown

in Figure 10a,b suggest that specimens P1 and P2 could achieve a minimum FRR of 60 min and specimen P3 of minimum 90 min, which is sufficient for use in residential and commercial buildings.

**Figure 10.** Comparison between the measured (a) displacements and (b) displacement rates.

(Figure 10). These discrepancies in the obtained results indicate the need to repeat the fire tests to draw strong conclusions and provide a broader basis for the results if modelling is used. Thus, the results obtained do not allow clear conclusions to be drawn regarding the uniformity of the results obtained and the subsequent FRR. If FRR is concerned, since the load was removed before the structural failure criteria were reached, it is hard to predict the behaviour of panels from test end onward. However, the results obtained on both specimens suggest that an FRR of at least 60 min can be achieved for LSF with combustible cavity insulation protected with two layers of GBF with reaction to fire A1.

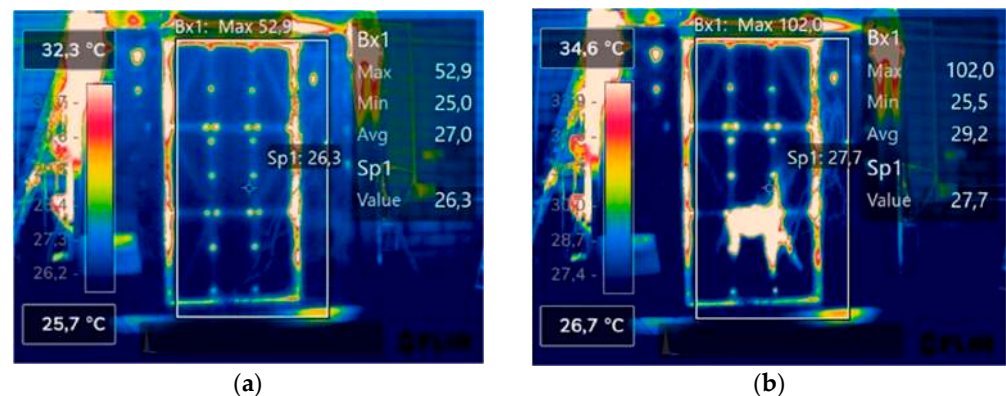
**Figure 11.** Thermograms for specimen P1: (a) in the 67th minute; (b) in the 76th minute.

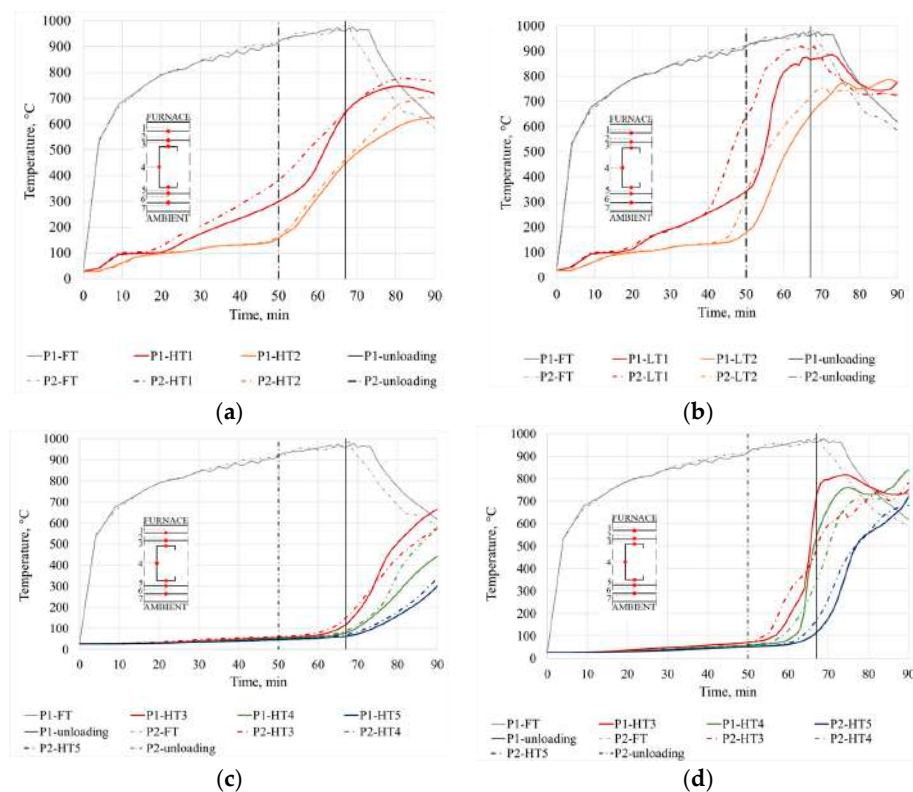
Since fire tests are expensive and time-consuming, the results are usually analysed, and conclusions are drawn from individual measurements. On the other hand, studies dealing with repeated fire tests with the same specimens have shown that fire tests are difficult to reproduce in terms of their physical quantities even though they were designed to be repeated under the same conditions [37]. Therefore, two nominally identical LSF panels (P1 and P2) are tested for comparison. Figure 12a,b show the comparison of the time–temperature curves recorded between the two GBFs (positions HT1 and LT1) and between the GFB base layer and the PUR insulation (positions HT2 and LT2) for specimens P1 and P2, while Figure 12c,d show the comparison of the time–temperature curves obtained at the steel studs at both thermocouple positions.

**Figure 12.** Comparisons of time–temperature curves for specimens P1 and P2: (a) average time–temperature curves recorded at GBFs (higher positions—HTs); (b) average time–temperature curves recorded at GBFs (lower positions—LTs); (c) average time–temperature curves recorded on steel studs at higher positions (HTs); (d) average time–temperature curves recorded on steel studs at lower positions (LTs).

Although specimens P1 and P2 were made from the same components, tested under the same conditions and exhibited similar failure modes, the degradation of specimen P2 began earlier. In general, the time–temperature curves recorded at GBFs at the lower positions for both specimens (Figure 12b) show greater differences compared to the analogous results recorded at the upper positions (Figure 12a). The location where the cracks are believed to have formed comes from the observations made from the thermograms (Figure 11) and it is located directly above nodes N6 and N7, where local buckling was observed during the post-test inspection. About 40 min after the start of the test, severe horizontal cracking and opening of the joints were observed on both specimens. The differences between the time–temperature curves in the steel members of specimens P1 and P2 are also high (Figure 12c,d), especially at lower position from the 50th minute onwards (Figure 12d). Consequently, the observed vertical deflection was more pronounced for specimen P2

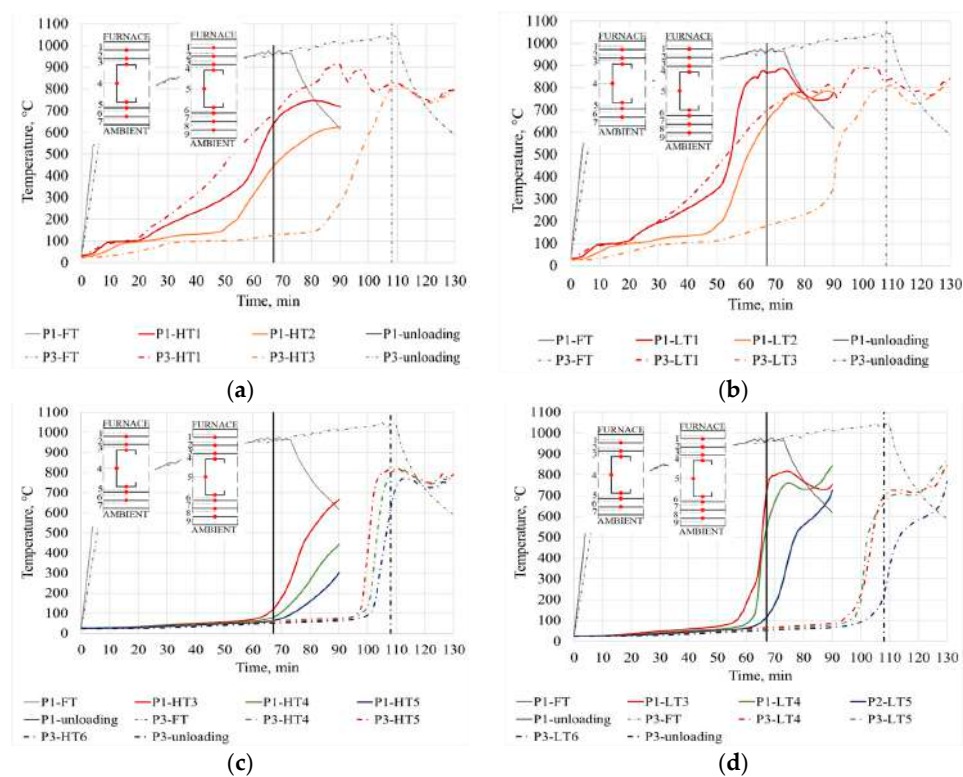
The comparison between specimens P1 and P3 was made with the aim of determining the effect of different arrangement, type and number of wallboard layers on the fire behaviour of studied LSF panels. Although specimen P3 did not fail up to the 108th minute, the purpose of this comparison is to evaluate the fire behaviour in the first 90 min. Since specimen P2 failed earlier than P1, specimen P1 was taken as more appropriate to determine the behavioural differences in a longer time frame. Comparing the time–temperature curves shown in Figure 13a,b, it can be seen that the addition of one layer of GBF in specimen P3, even if inner ones are of A2 GFB, significantly affected the temperature development at the interface between the base layer and the insulation (P1-(H/L)T2 vs. P3-(H/L)T3). The temperatures for both specimens between the two exposed wallboards at positions HT1 and LT1 were similar until the 20th minute. After the 20th minute, the temperatures between the exposed wallboards in specimen P3 began to be significantly higher than the analogous temperatures in specimen P1. This difference is much more pronounced at the higher positions, P3-HT1 vs. P1-HT1, see Figure 13a. This significant temperature increase could be attributed to the formation of cracks in specimen P3.

**Figure 13.** Time–temperature curves comparisons for specimen P1 and P3: (a) average time–temperature curves for higher positions (HTs); (b) average time–temperature curves for lower positions (LTs); (c) average time–temperature curves measured on the steel studs (HTs); (d) average time–temperature curves measured on steel studs (LTs).

At the time of unloading specimen P1 (67th minute), the temperatures at the interface between the inner wallboards and the insulation were significantly lower. The temperature difference between the interface of the wallboards and insulation at the higher thermocouple position (P1-HT2 and P3-HT3, Figure 13a) was 321 °C. The temperature difference at the lower thermocouple positions (P1-LT2 and P3-LT3, Figure 13b) was even higher—467 °C. Comparing the temperatures recorded at the steel studs for the whole test period, it can be seen that the temperatures in specimen P3 remained below 100 °C at both the lower and higher positions (see Figure 13c,d). Comparing the hot flange temperatures at lower positions, the difference is 656 °C (Figure 13d) at the 67th minute of the test.
